# Manhole Inspection Summary

Manhole # S25MM\_002MH

**Location** Address: **2262 LINDEN AVE**

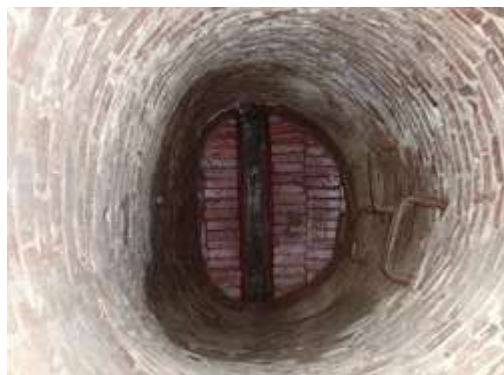
Top View

Barrel infiltration. Corroded and missing steps. Evidence of surcharge - Bench debris.

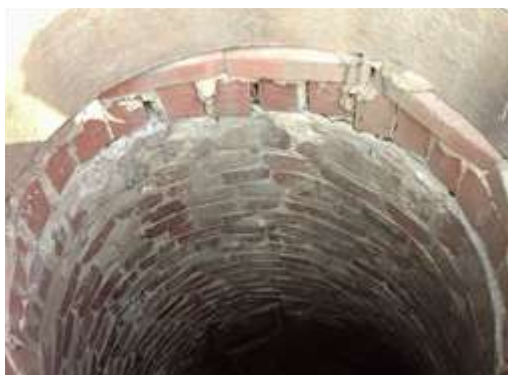
Defect

Frame leaks. Adjustment deterioration, loose brick and infiltration. Corbel and Barrel infiltration - other side.

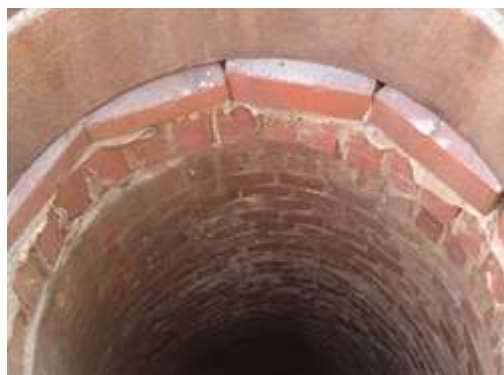
Defect

Frame leaks. Adjustment deterioration, loose brick and infiltration. Corbel and Barrel infiltration.

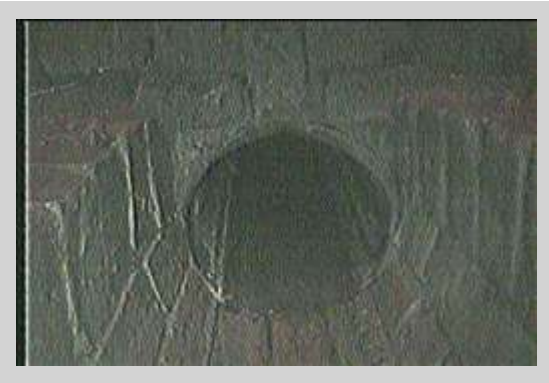
### 8 in. Circular Gravity Sewer Pipe Out @ 12 O'Clock

Deposits: ☐ None ☐ Mud ☐ Sludge ☐ Debris ☒ Grease

Infiltration: **Evidence** Pipe Seal Cond: **Cracked**

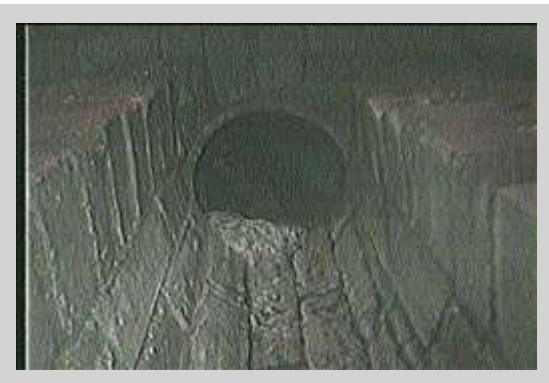
### 8 in. Circular Gravity Sewer Pipe In @ 6 O'Clock

Barrel deterioration and infiltration. Channel deterioration.

Deposits: ☐ None ☐ Mud ☐ Sludge ☒ Debris ☐ Grease

Infiltration: **Evidence** Pipe Seal Cond: **Broken**
